# PROPERTY INSPECTION

**Visual Building Inspection Report**

**Inspection address:** 8 Brisbane St, Fairlight NSW 2094

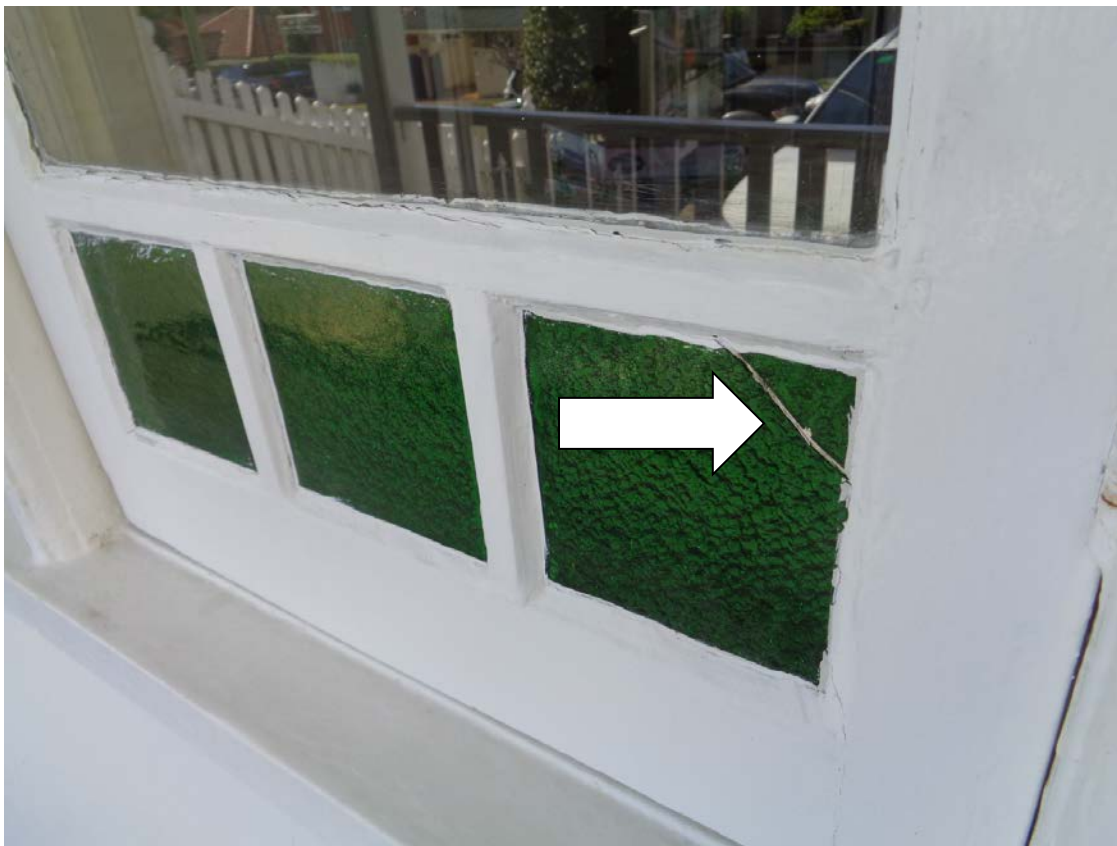
Cracked glass panel insert

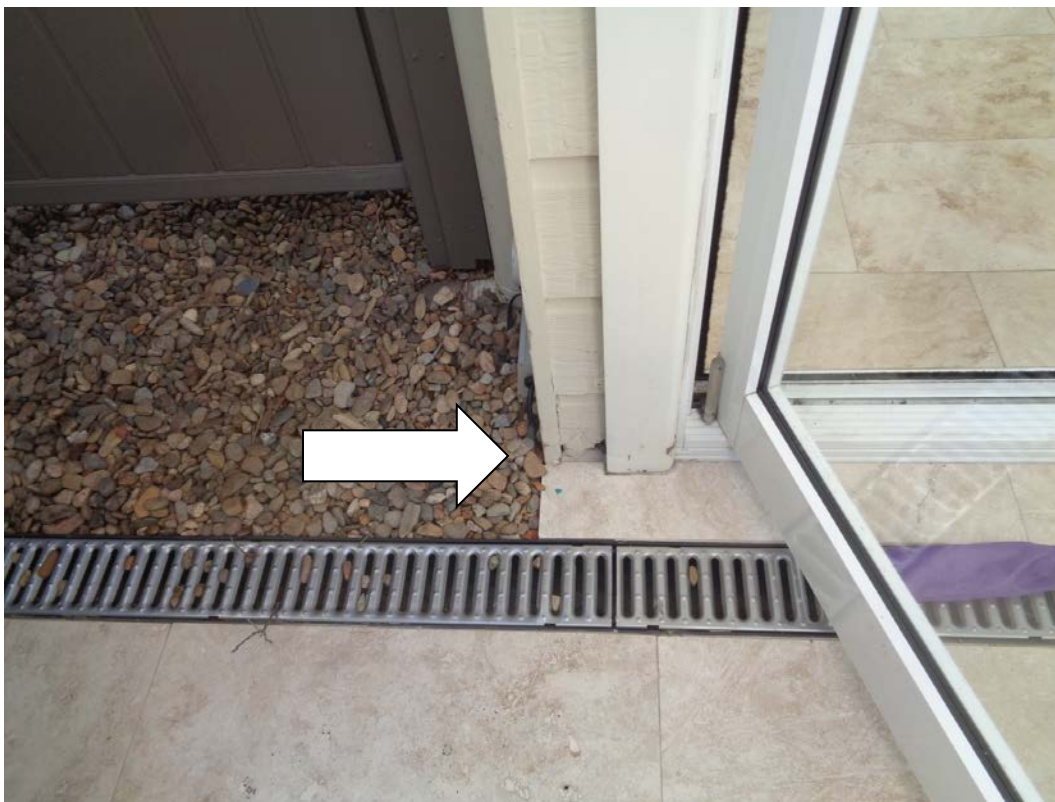
Damaged cladding

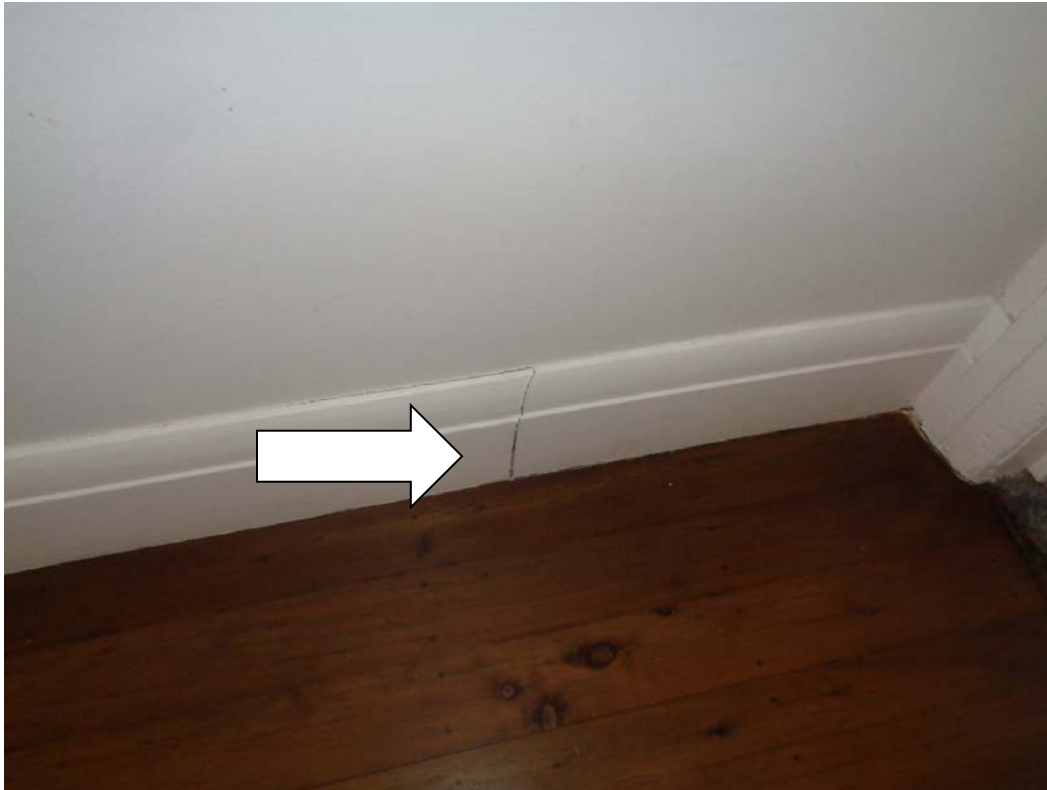
Timber skirting gap

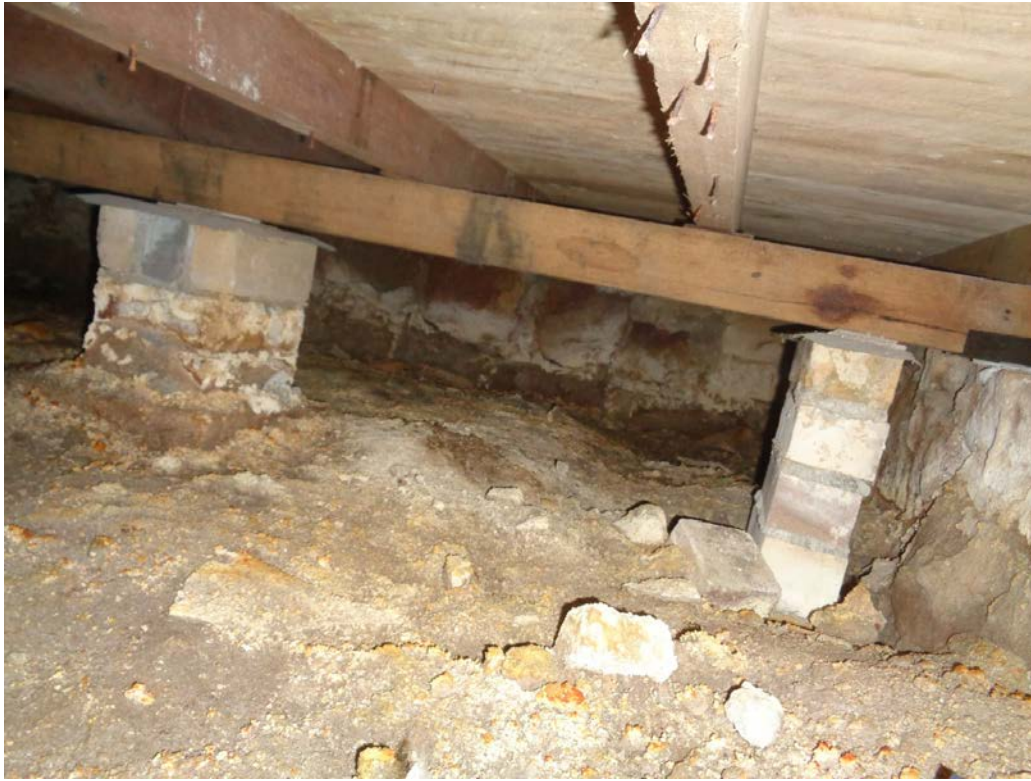
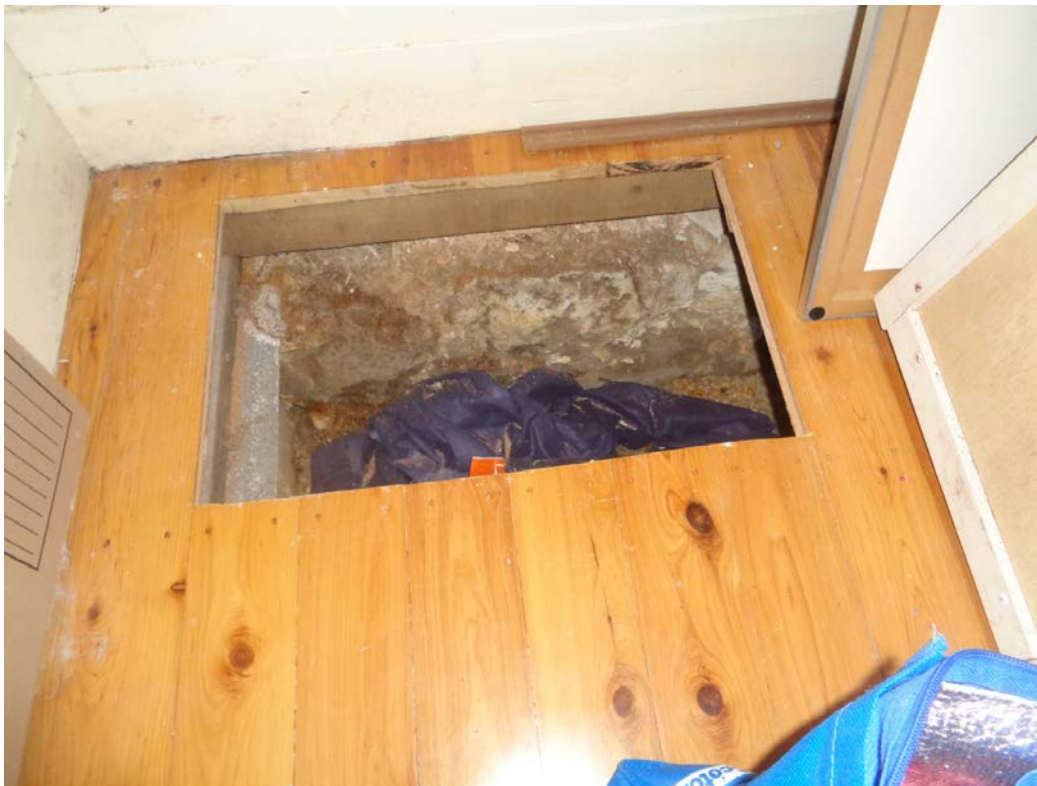
Sub floor access. Unable to gain full access
